## SYNERGISTIC DEGRADATION MECHANISMS OF SiC/BN/SiC IN OXIDIZING ENVIRONMENTS AT INTERMEDIATE TEMPERATURES UNDER LOAD

Elizabeth Opila, University of Virginia, USA  
opila@virginia.edu  
Kaitlin Detwiler, University of Virginia, USA

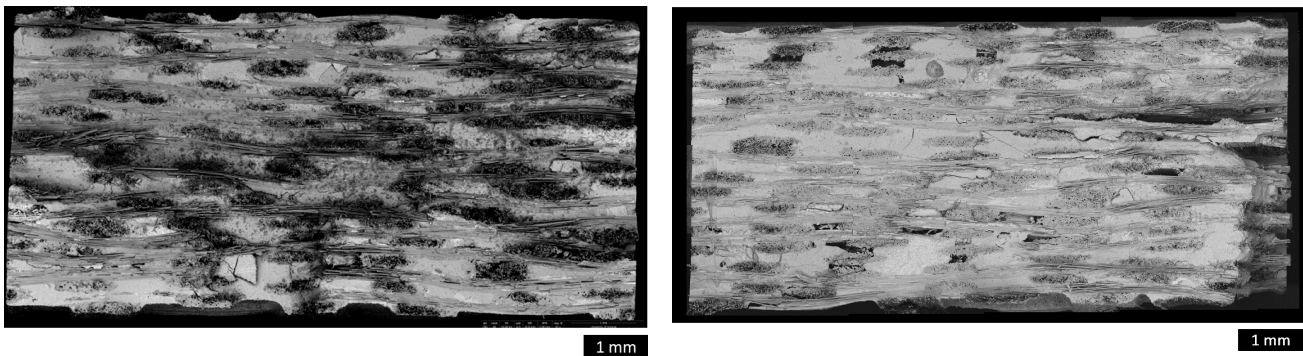
SiC-based ceramic matrix composites (CMCs) are subject to degradation in load-bearing, high-temperature, water vapor-containing combustion environments. In this presentation, mechanisms for degradation of SiC/BN/SiC composites from Rolls-Royce HTC CMCs were studied at three levels of applied load, intermediate temperatures (600 or 800°C), and three different oxidizing (air, dry oxygen, wet oxygen) conditions to explore synergies between load and thermochemical environment. The intent of the study was to hold the CMCs in these stressed high temperature oxidizing conditions and study crack formation and oxidation via microscopy methods, without stress rupture, to track the kinetics of cracking and oxidation degradation. Three stress levels were chosen based on room temperature fast fracture results, where the CMC exhibited i) first matrix cracking (150 MPa), ii) increased crack density (180 MPa), and iii) matrix saturated with cracks (200 MPa), wide crack opening displacements, and initiation of fiber failure. One key observation for CMC degradation without applied load is that at 600°C in 50 v% water vapor/50 v% O<sub>2</sub> environments, SiO<sub>2</sub> growth is slow and BN oxidation/volatilization is rapid resulting in annular voids forming around each fiber. Under other conditions studied, protective surface oxidation was observed that preserved the BN interphase. The 600°C, 50 v% water vapor/50 v% O<sub>2</sub> temperature test condition resulted in a unique failure mechanism when CMCs were under applied load. The figure below compares the fracture surface for specimens that failed at 800°C 200 MPa in lab air (left) vs. a failure observed after exposure at 600°C 150 MPa in 50 v% water vapor/50 v% O<sub>2</sub> (right). Dark regions indicate the desired fiber pullout, essential for CMC toughening, and bright regions indicate brittle fracture. Note the 800°C lab air failure tends to have the expected fracture morphology of smooth regions around the edges of the coupon indicating oxidation embrittlement where oxidant is able to penetrate into the composite through cracks. In contrast, the 600°C failure has a smooth fracture surface throughout most of the fracture section with some fiber pullout around the edges. High magnification microscopy shows that the fibers with pull-out for the right-hand sample have no boron nitride interphase material remaining. This fracture morphology observed after exposures at 600°C in 50 vol% water vapor/50 v% O<sub>2</sub> suggests there are numerous gas phase diffusion paths into the interior of the composite due to rapid loss of BN without significant SiO<sub>2</sub> growth. To summarize, the CMC degradation mechanism for the 600°C, 150 MPa, 50 v% H<sub>2</sub>O/50 v% O<sub>2</sub> exposure is BN oxidation/volatilization first, followed by matrix cracking and fracture. The 800°C, 200 MPa, lab air CMC failure is suggestive of local surface cracking damage first, allowing oxidant transport inwards followed by local embrittlement and fracture.

SiC/BN/SiC fracture surfaces after exposures. Left: 800°C, 200 MPa, lab air failure at 49h vs. Right: 600°C, 150 MPa, 50 v% H<sub>2</sub>O/50 v% O<sub>2</sub> failure at 26h.
