DURABILITY INVESTIGATION OF BURNER RIG OF Yb_2SiO_5 ENVIRONMENTAL BARRIER COATINGS

Masahiro Negami, Kawasaki Heavy Industries, Ltd., Japan
negami_masahiro@khi.co.jp
Kohei Kyuma, Kawasaki Heavy Industries, Ltd., Japan
Yasuhiro Takada, Kawasaki Heavy Industries, Ltd., Japan
Takeo Oda, Kawasaki Heavy Industries, Ltd., Japan
Masayoshi Kobayashi, Japanese Aero Engines Corporation
Makoto Azuma, Kawasaki Heavy Industries, Ltd., Japan

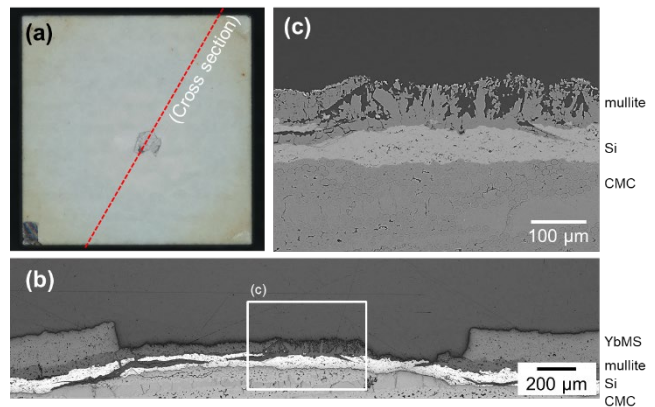
The test was interrupted after 1350 cycles because partial EBC delamination was observed (Figure 2(a)). From the optical microscopy image (Figure 2(b)) and scanning electron microscopy image (Figure 2(c)) of the cross-section of the delaminated area, it was confirmed that thermally grown oxide was formed along the cracks owing to the oxidation of the Si bond coat. In addition, the mullite layer appeared porous, owing to steam oxidation. Because no recession of mullite was reported in the furnace steam oxidation tests [1], it is considered that this degradation phenomenon is unique to the burner rig test. Under conditions in which EBCs are exposed to high-velocity water vapor, water vapor may penetrate the EBCs through cracks generated during cyclic tests and cause recessions in the intermediate layer.

Figure 2 – EBC sample after burner rig test. (a) appearance; (b)(c) cross-section images.
