Material weakening due to corrosion in hardened bearing steels

International workshop on the environmental
damage in structural materials under static
load/cyclic loads at ambient temperatures

Cork, Ireland, June 1st, 2016

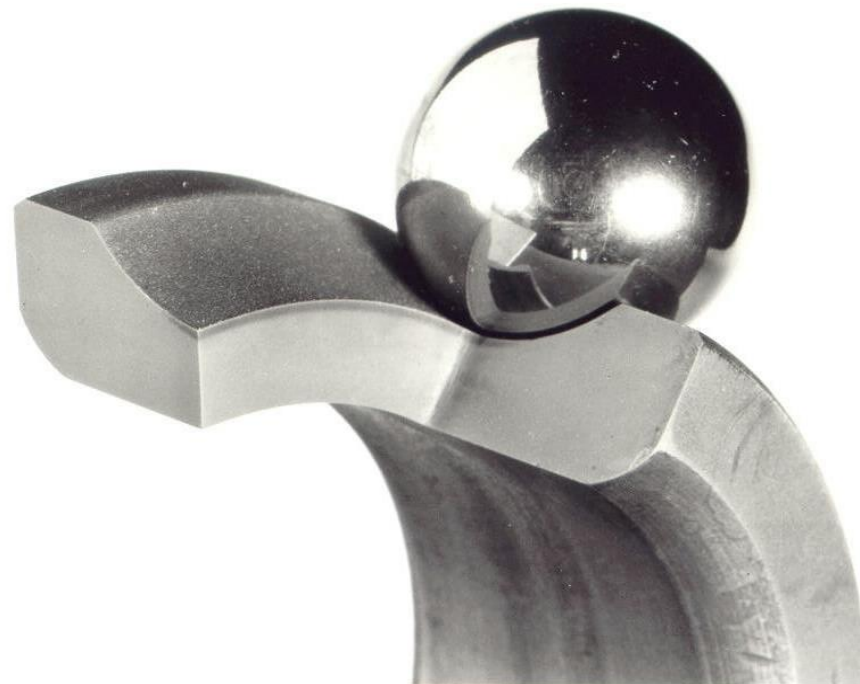
Fatigue development in bearing components

- Bearings require resistance to *Very High Cycle Fatigue* ($>10^{10}$ revolutions)
- Loads are up to 4 GPa
- Load distribution is described by the Hertzian stress profile

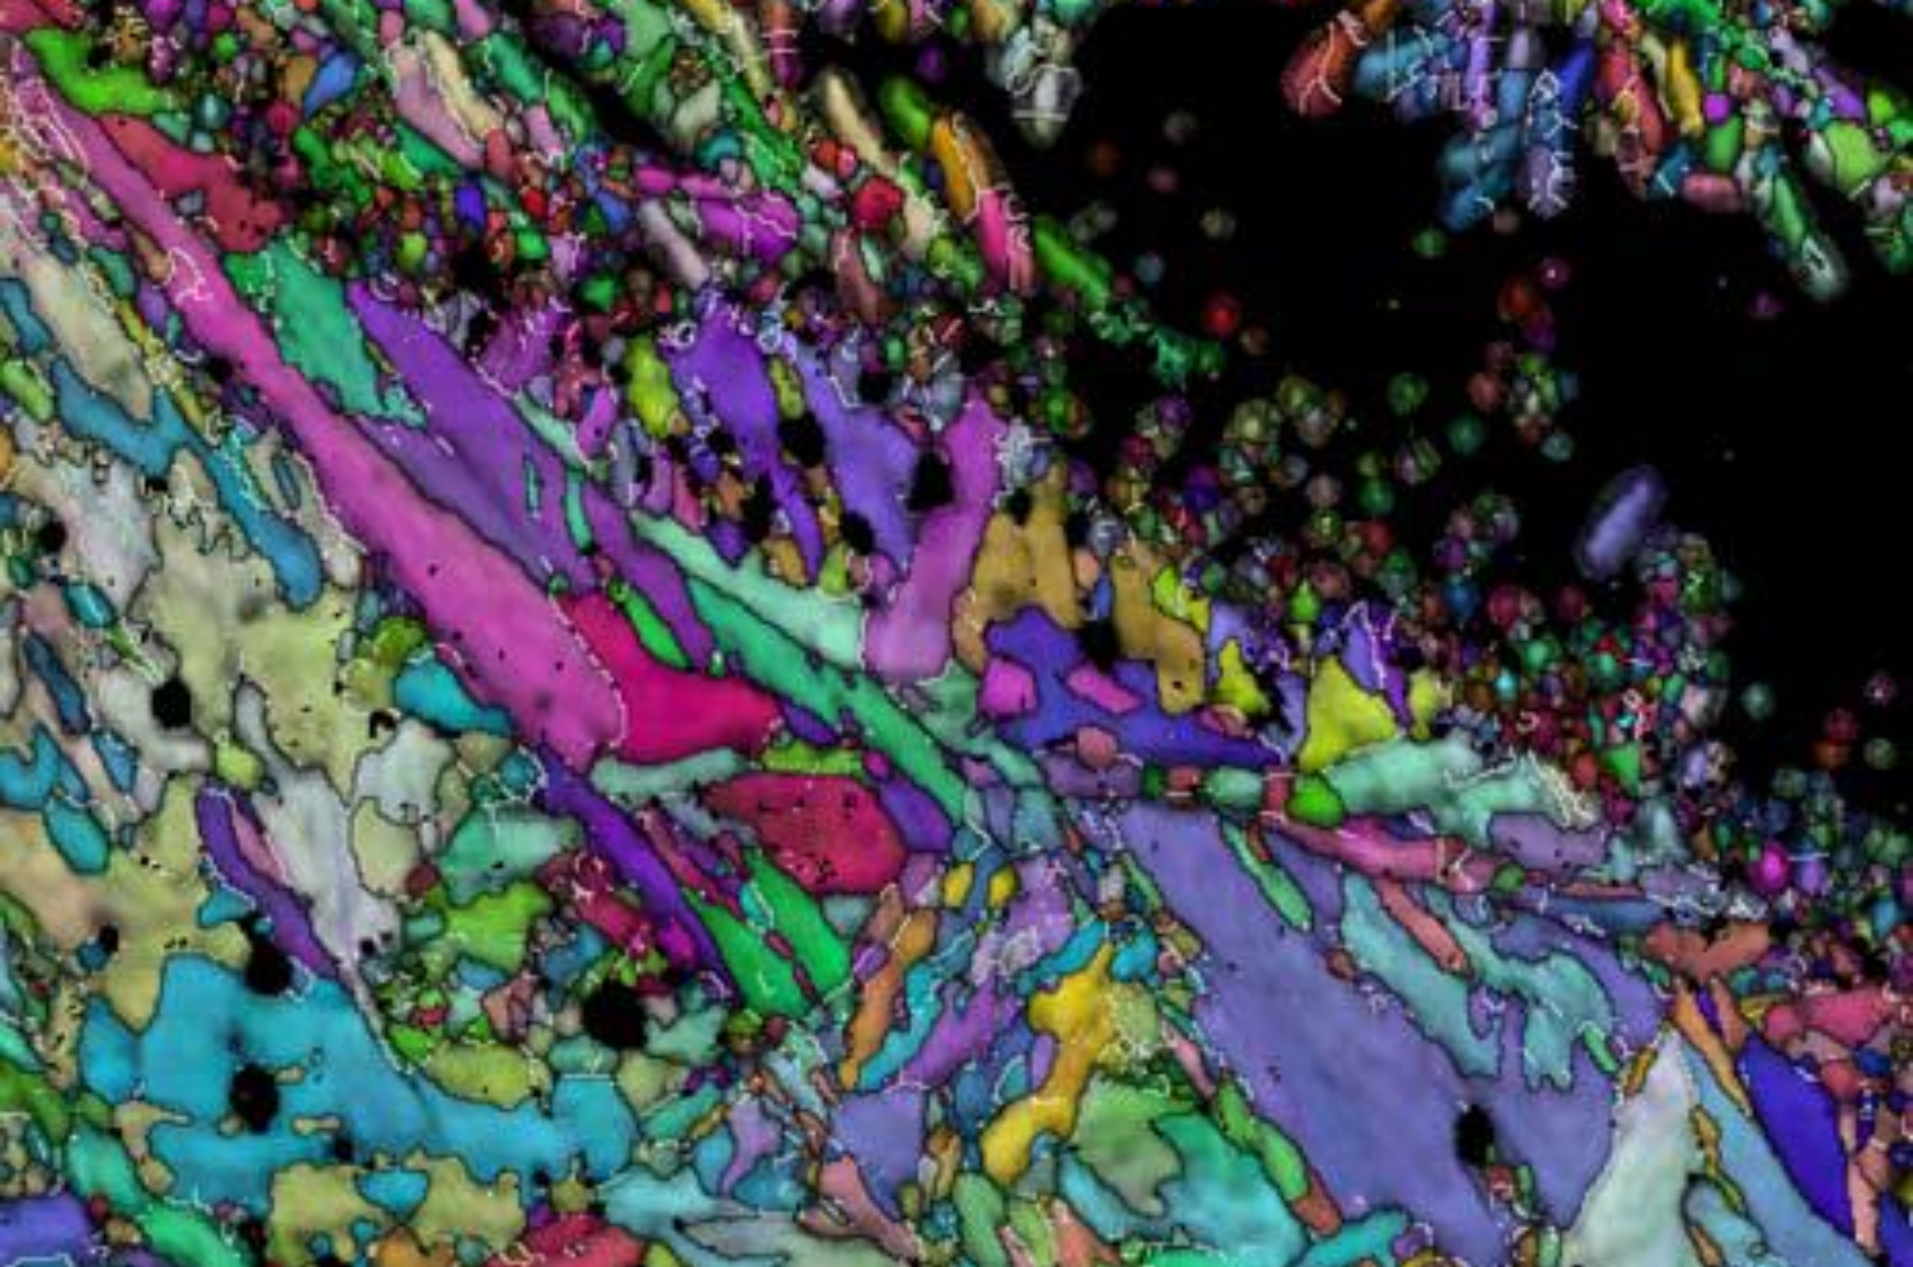
Localized fatigue damage development

Fatigue damage initiating non-metallic inclusion

Tapered roller bearing, tested 3x nominal life under 1.8 GPa contact pressure

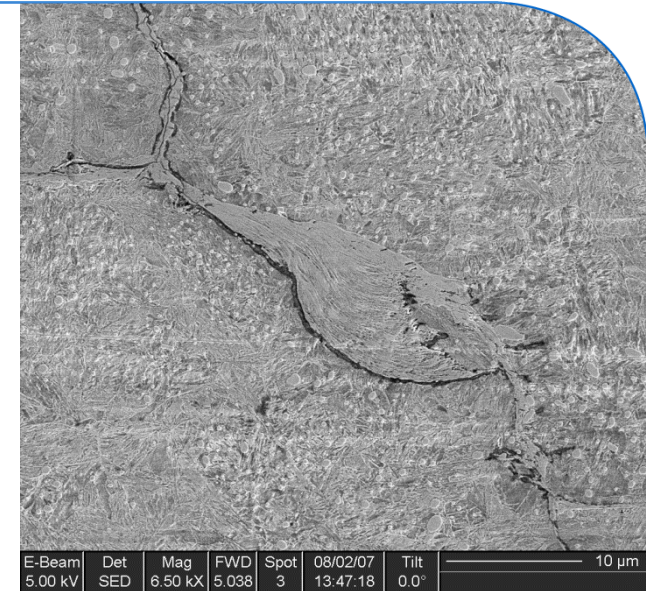
WEC in Self Aligning Ball Bearing tested with increased hydrogen content

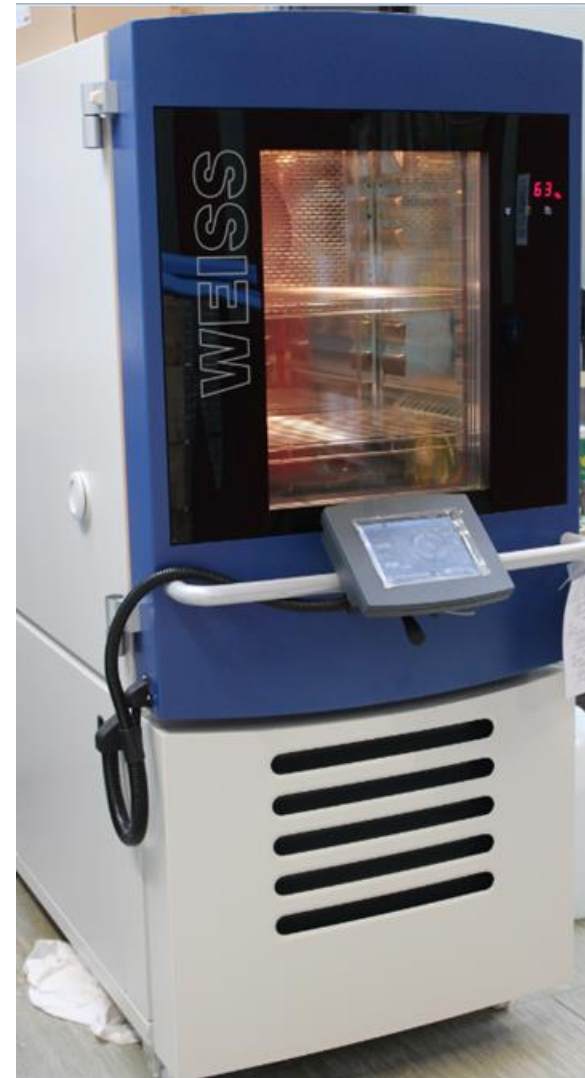
Corrosion in a climate chamber

Two tests were performed:

Rollers of NU 205 ECP were cleaned and put directly in the climate chamber

Rollers of NU 305 ECP were cleaned and wrapped together using tie-wraps in bunches of 3 rollers. These were also put in the climate chamber

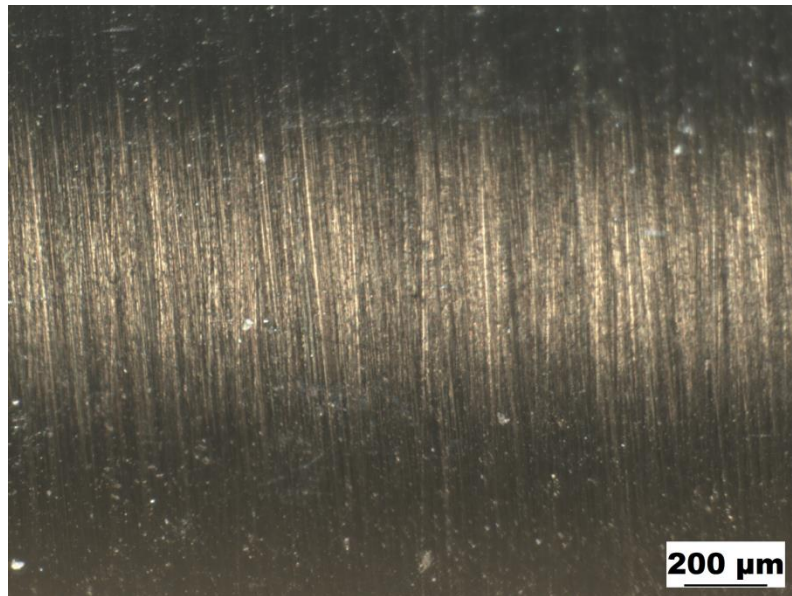
3 Rollers tested for 29 cycles in a climate chamber

No preservative removal

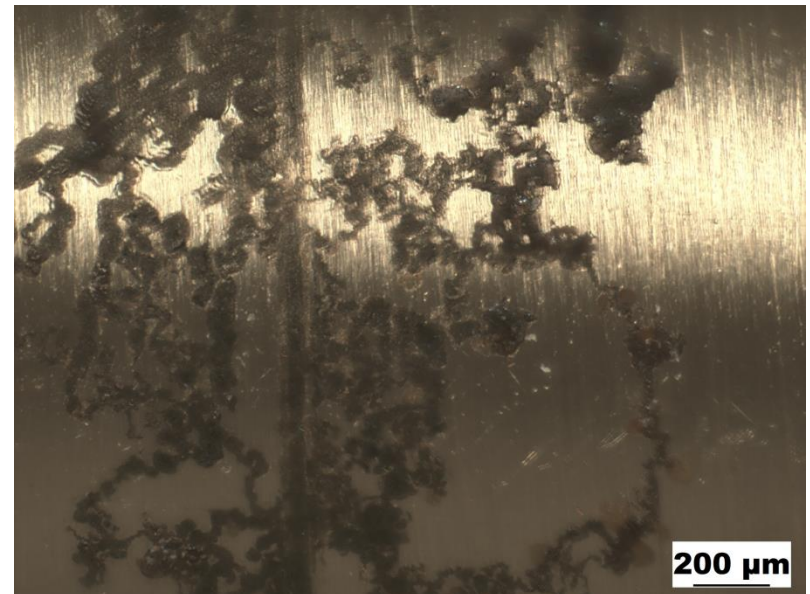
Cleaned before test

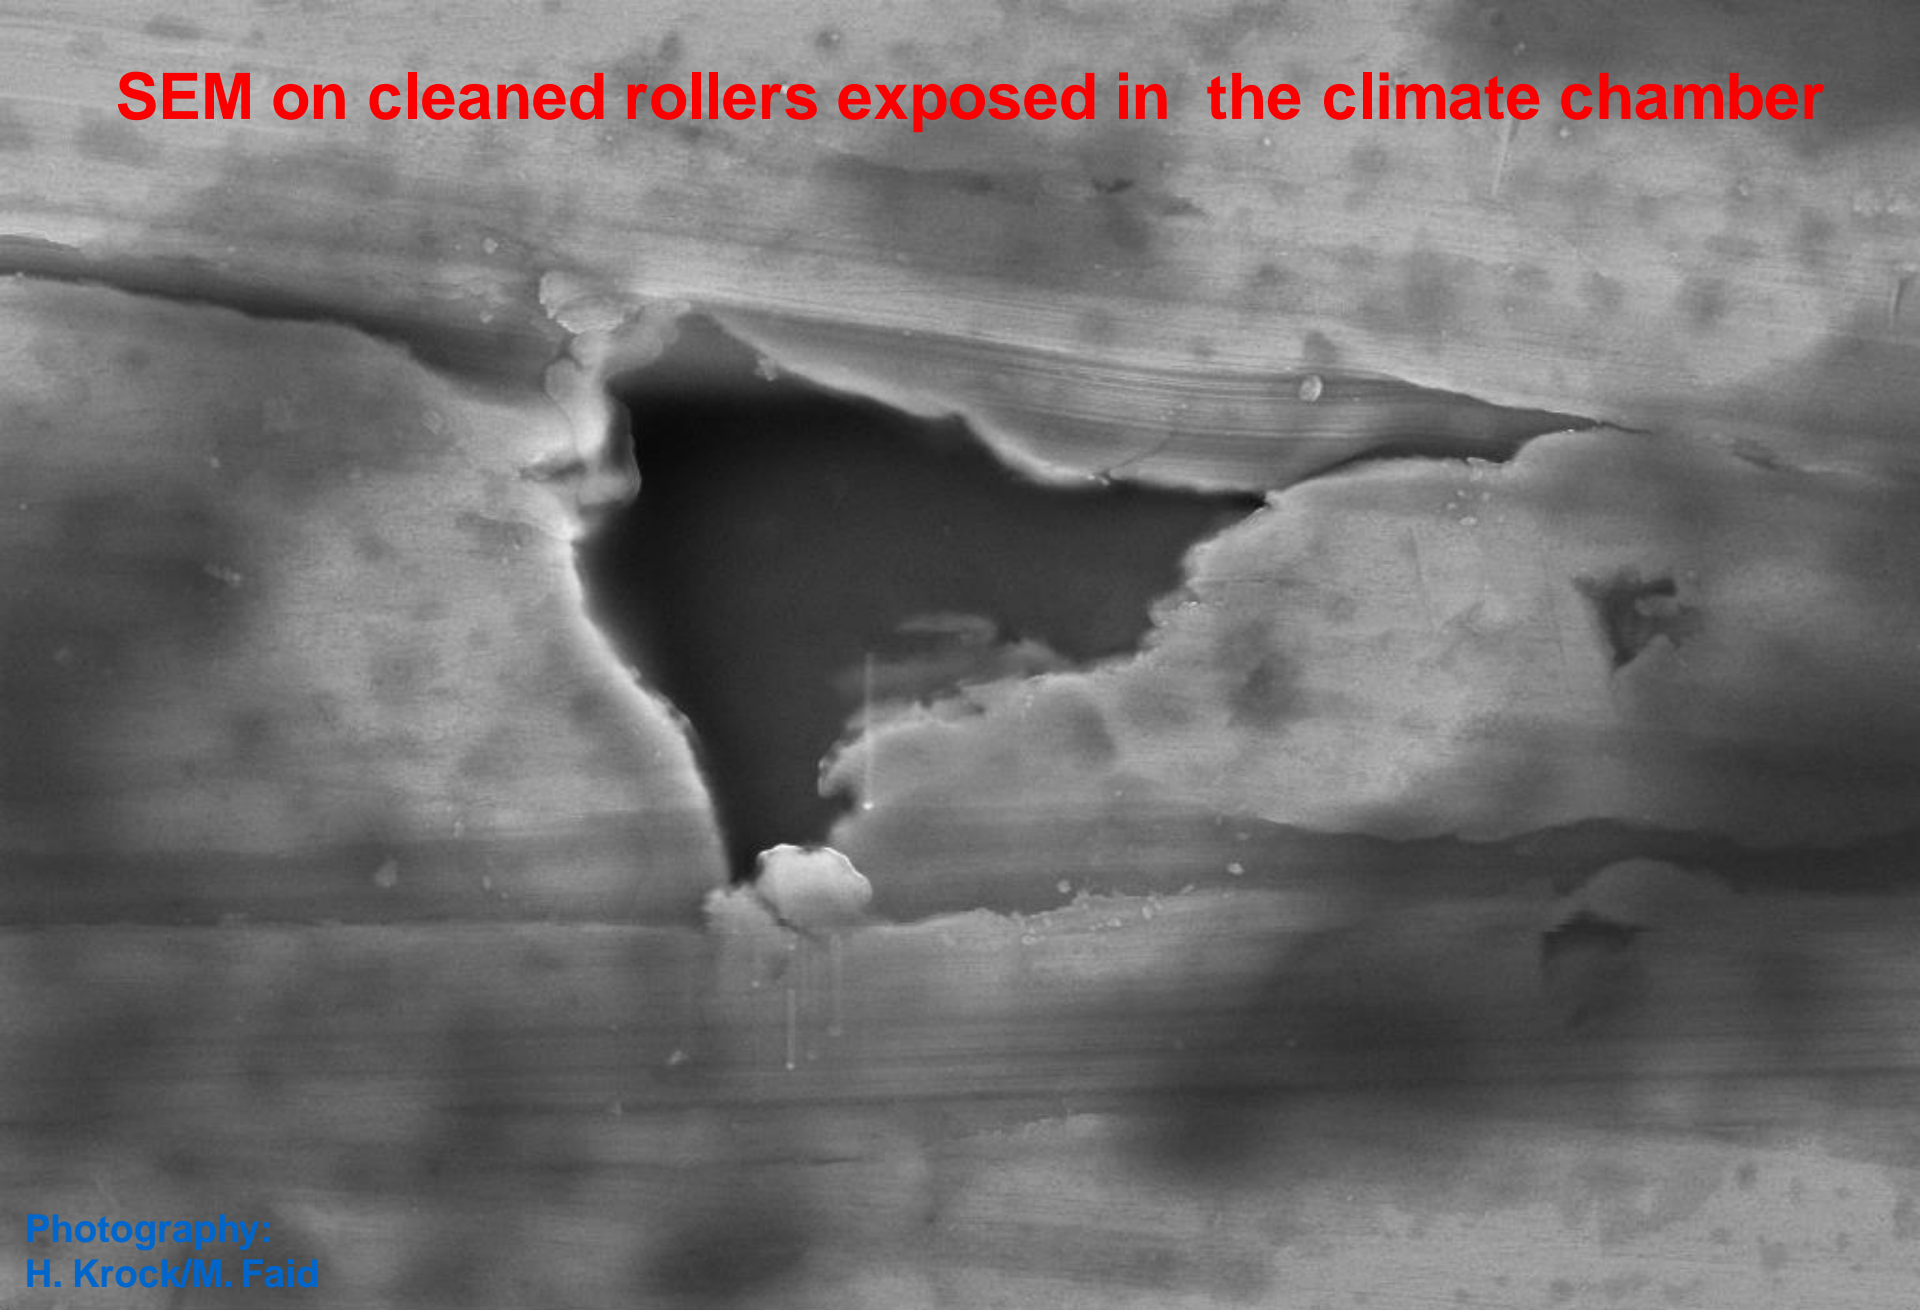
SEM on cleaned rollers exposed in the climate chamber

Exposure of single rollers leads to pitting corrosion

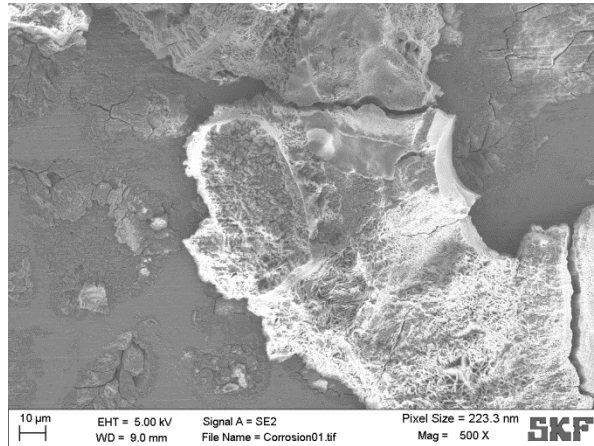
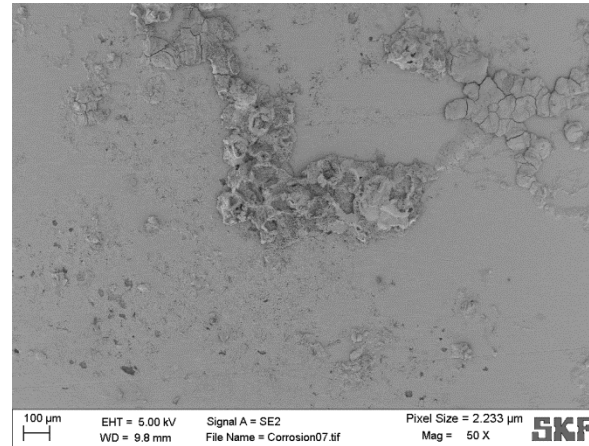
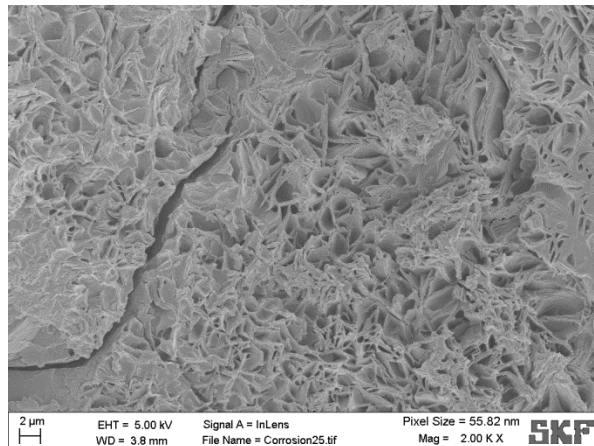
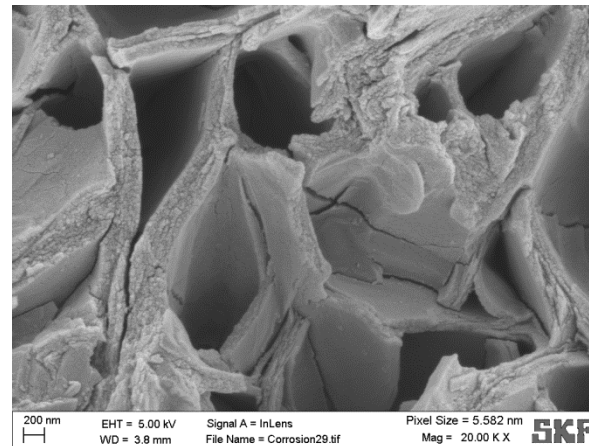
3 Rollers wrapped together in a climate chamber

At the contact of the rollers, crevice corrosion occurs

Rollers in contact show 'crevice corrosion'

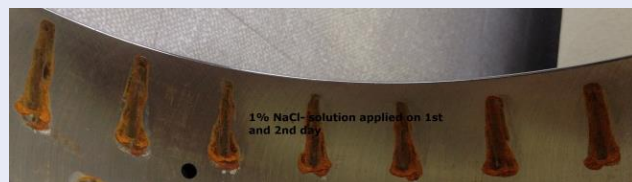
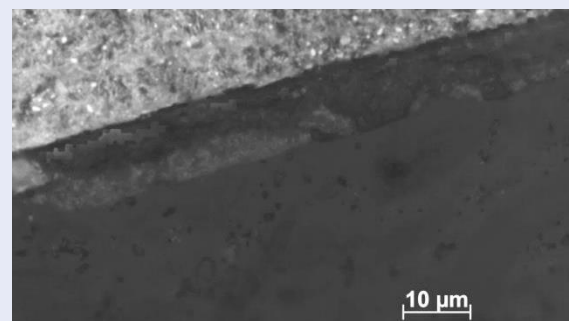
20 μ l 1%NaCl,
on each roller/ring
contact
Inspect after 1 day

20 μ l 1%NaCl on
each roller/ring contact
Inspect after 4 days

Day 1 20 μ l +
20 μ l day 2, 1%NaCl
on each roller/ring
contact
Inspect after 4 days
after the first application

The average of three measurements

Wiped and washed bearing,
No grease or preservative during corrosion process
20 μ l of 1 % NaCl- distilled water solution
Vertical position

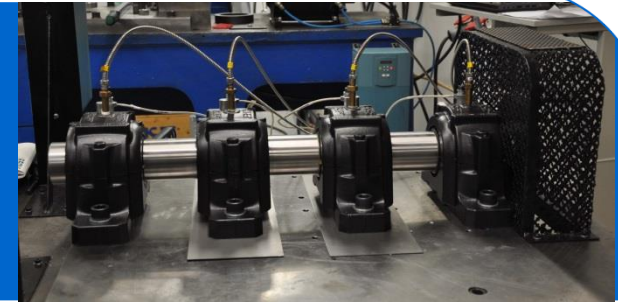
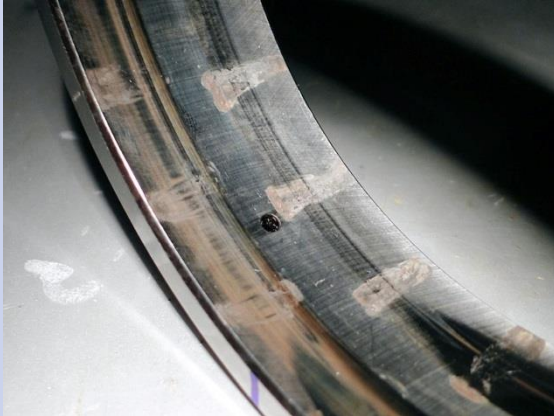
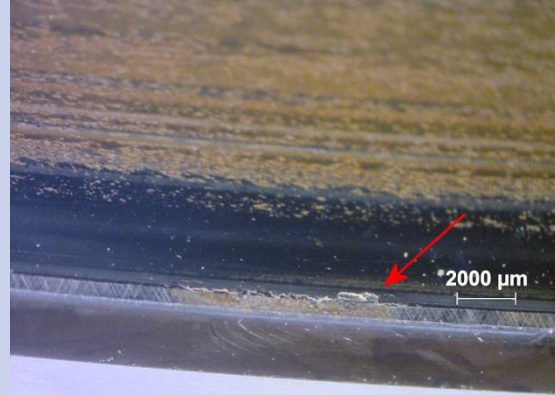
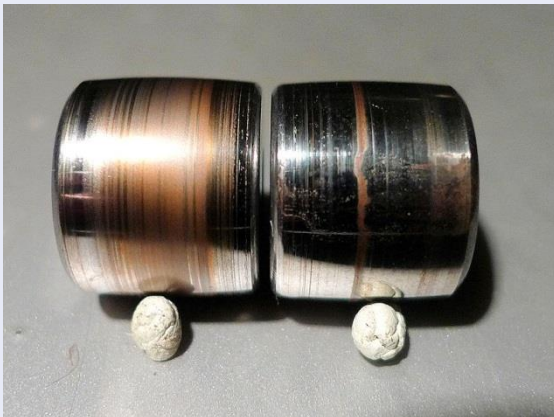
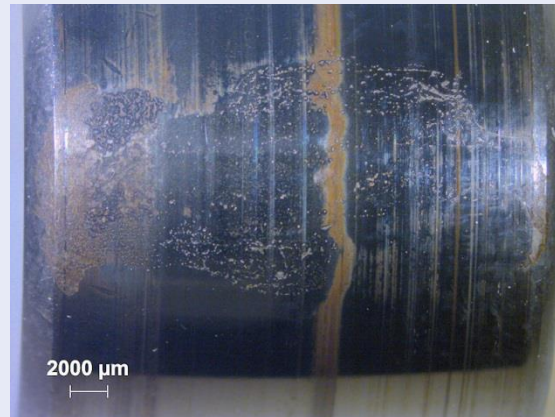
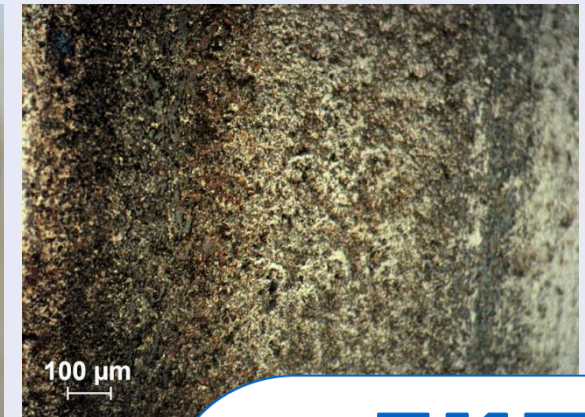
Run the severely corroded bearings as a first try => Surface initiated failure mode

Bearing tests in rig

- Failure after about 300-800 hrs
- Similar visible results and no subsurface cracks
- Only one BF found in two investigated bearings

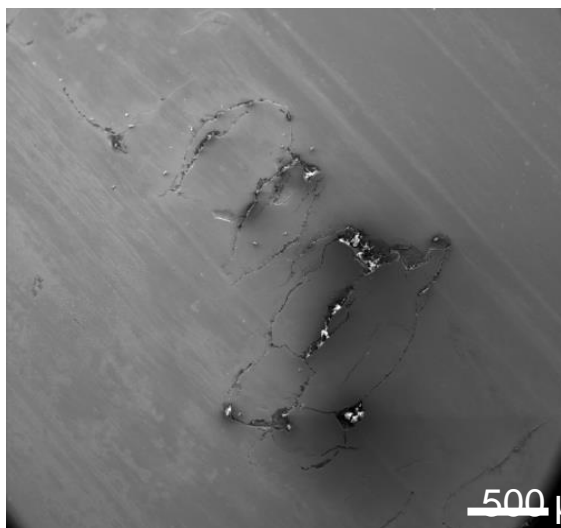
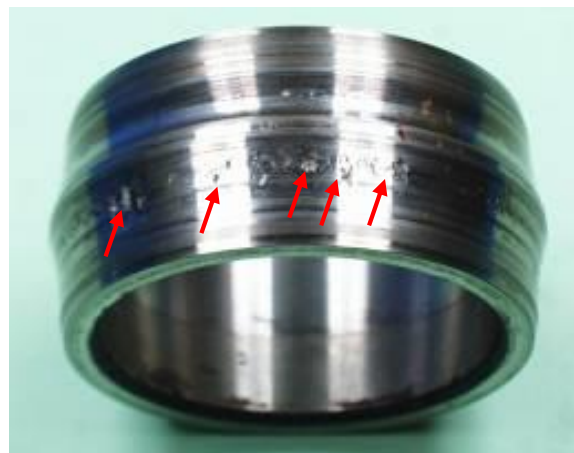
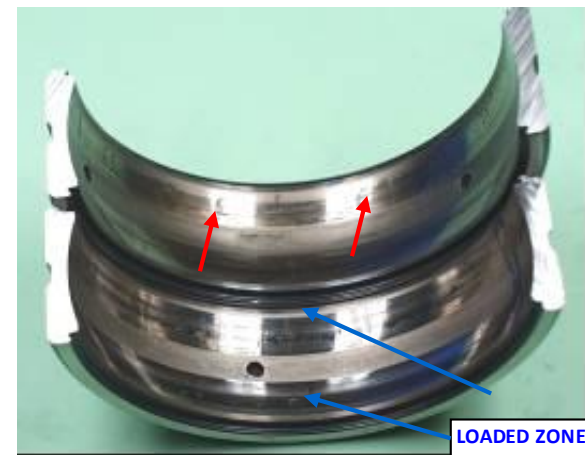
Standstill corrosion tests

Tested bearing with water in the grease (Shell Nerita HV), standstill corrosion.

- Radial load 10 kN
- Test time 13x120 h with 48 h standstill after each 120 h
- 0.5 ml water was added to the grease at every standstill
- Every second standstill the bearing was re-lubricated

Several failures occurred, microstructural investigations were performed

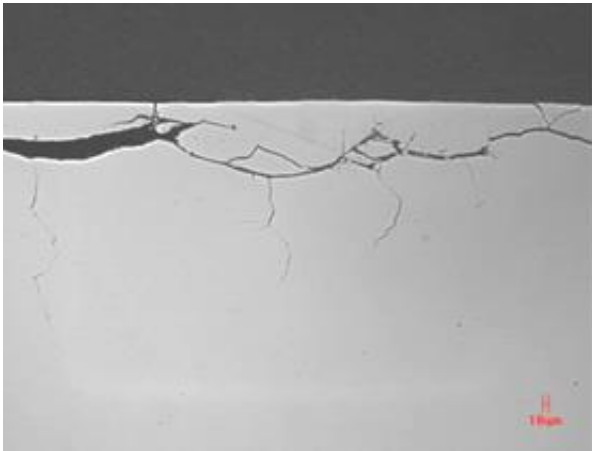
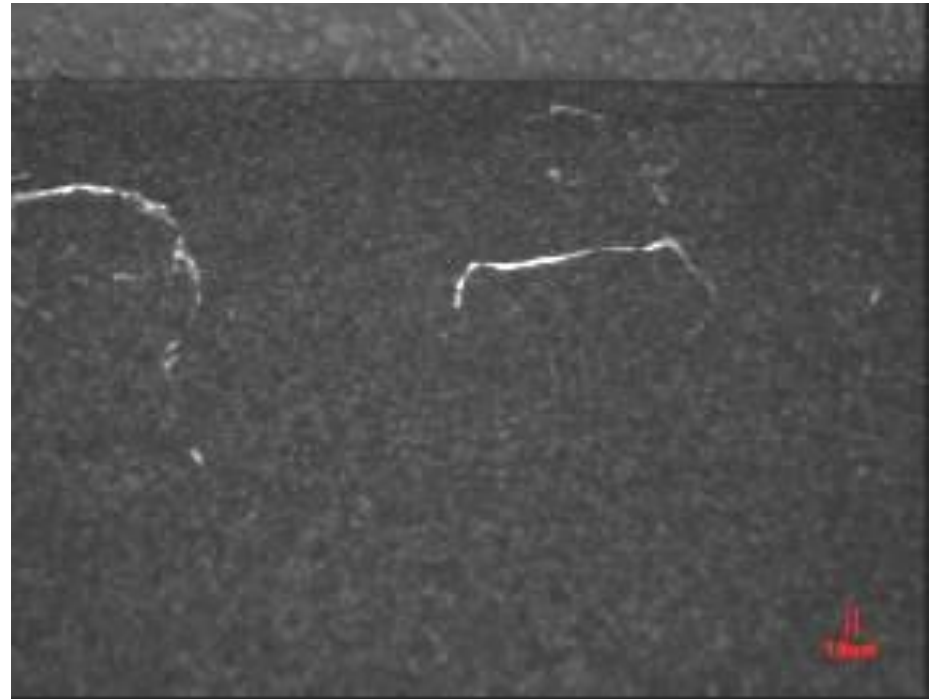
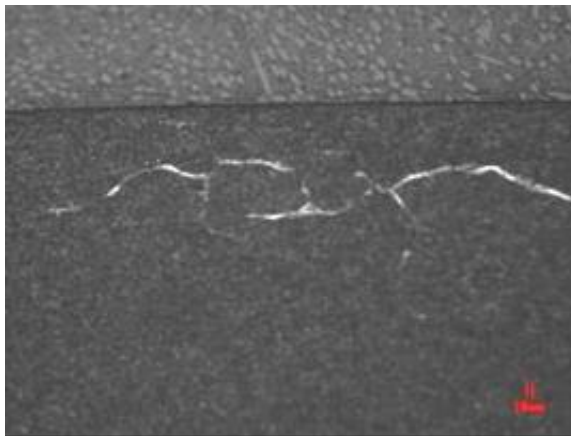
Sub-surface fatigue

In the bearings with water in grease, accelerated fatigue is observed, leading to extensive cracking with some White-Etching areas around it.

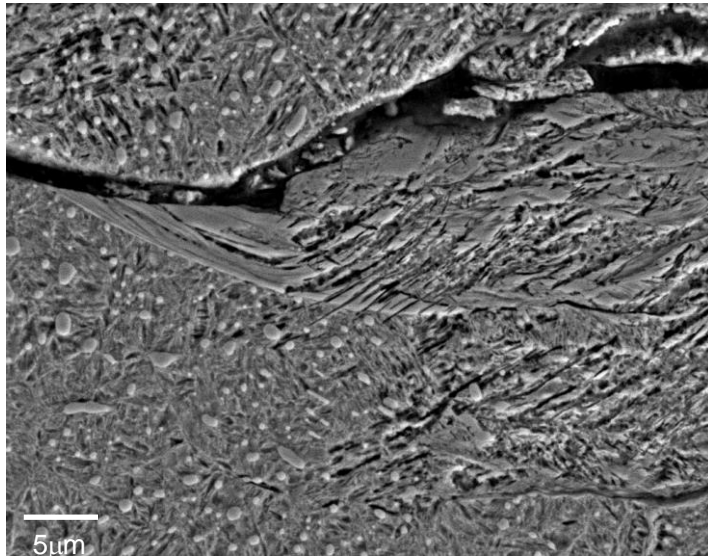
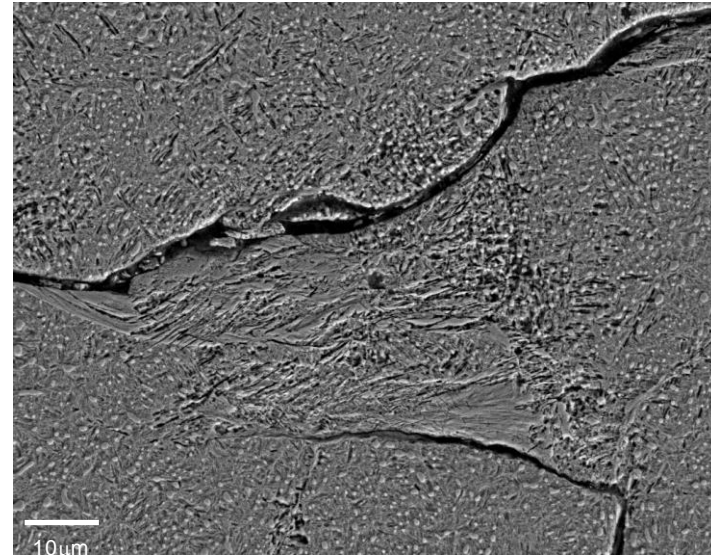
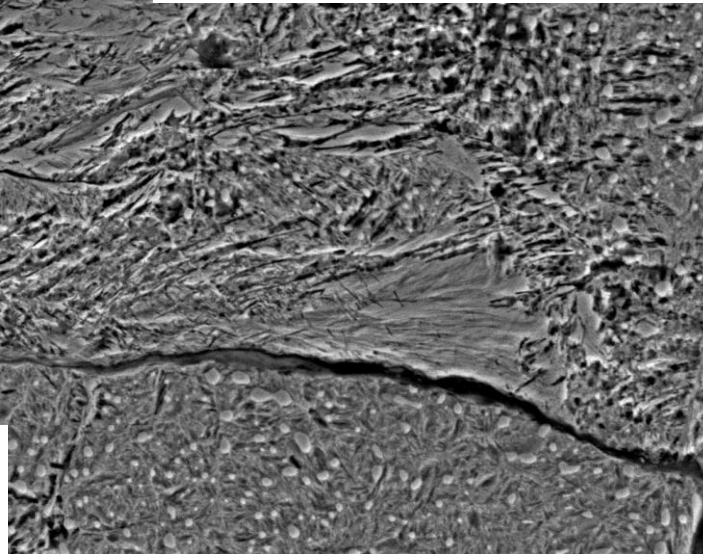
Extensive White-Etching Cracking due to corrosion

Sub-surface WEC in tested bearing with water in grease after standstill corrosion

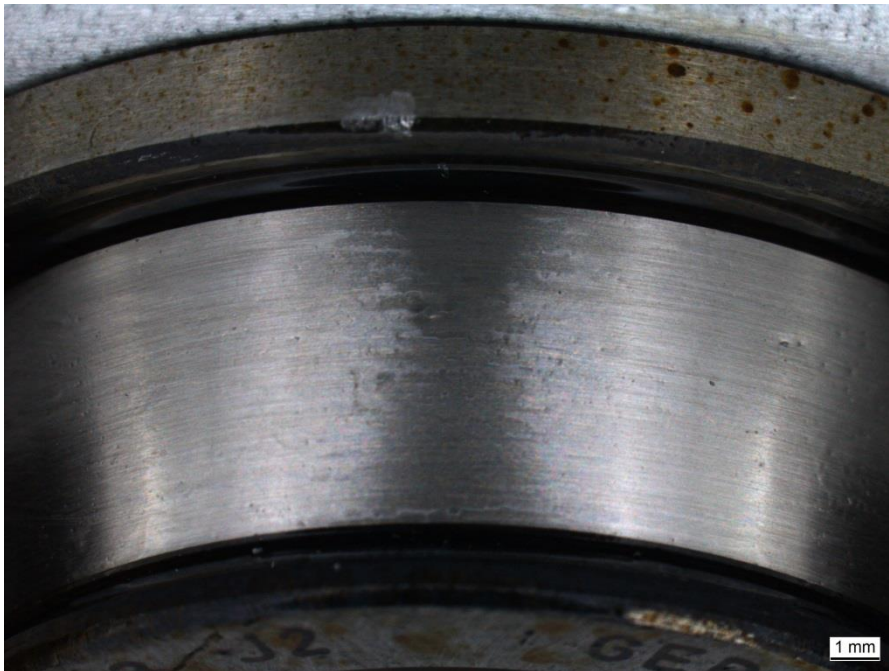
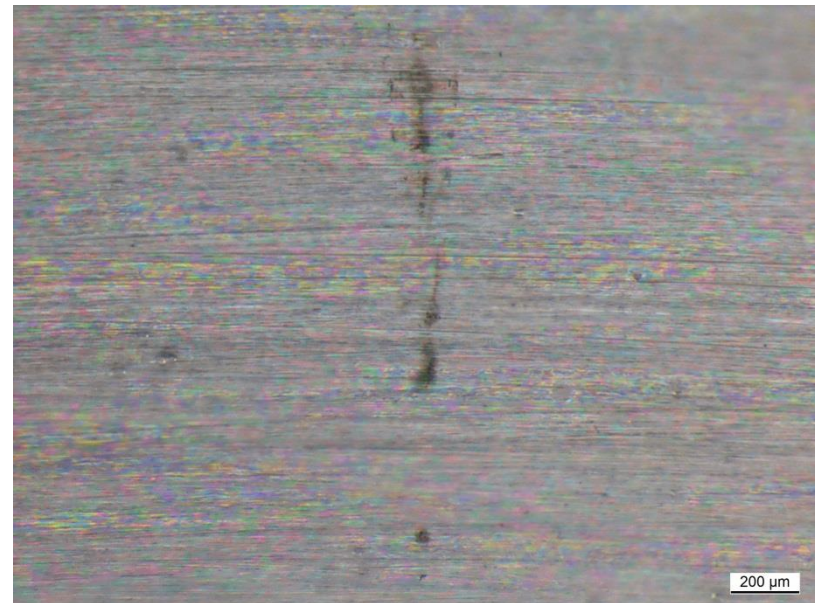
Optical observations

Standstill corrosion marks very difficult to find

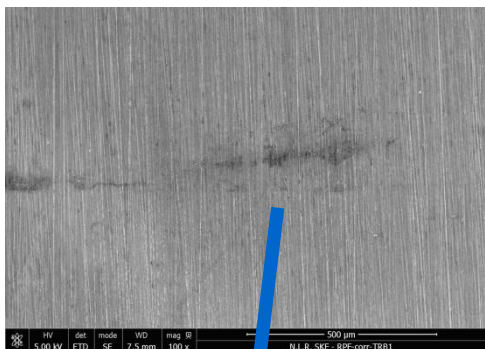
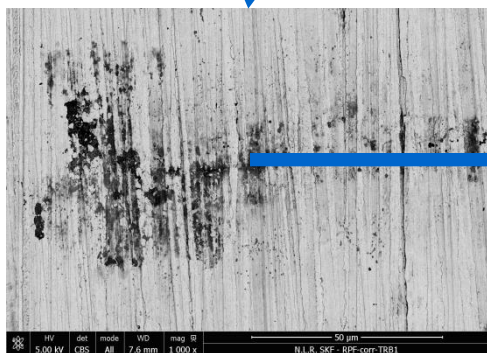
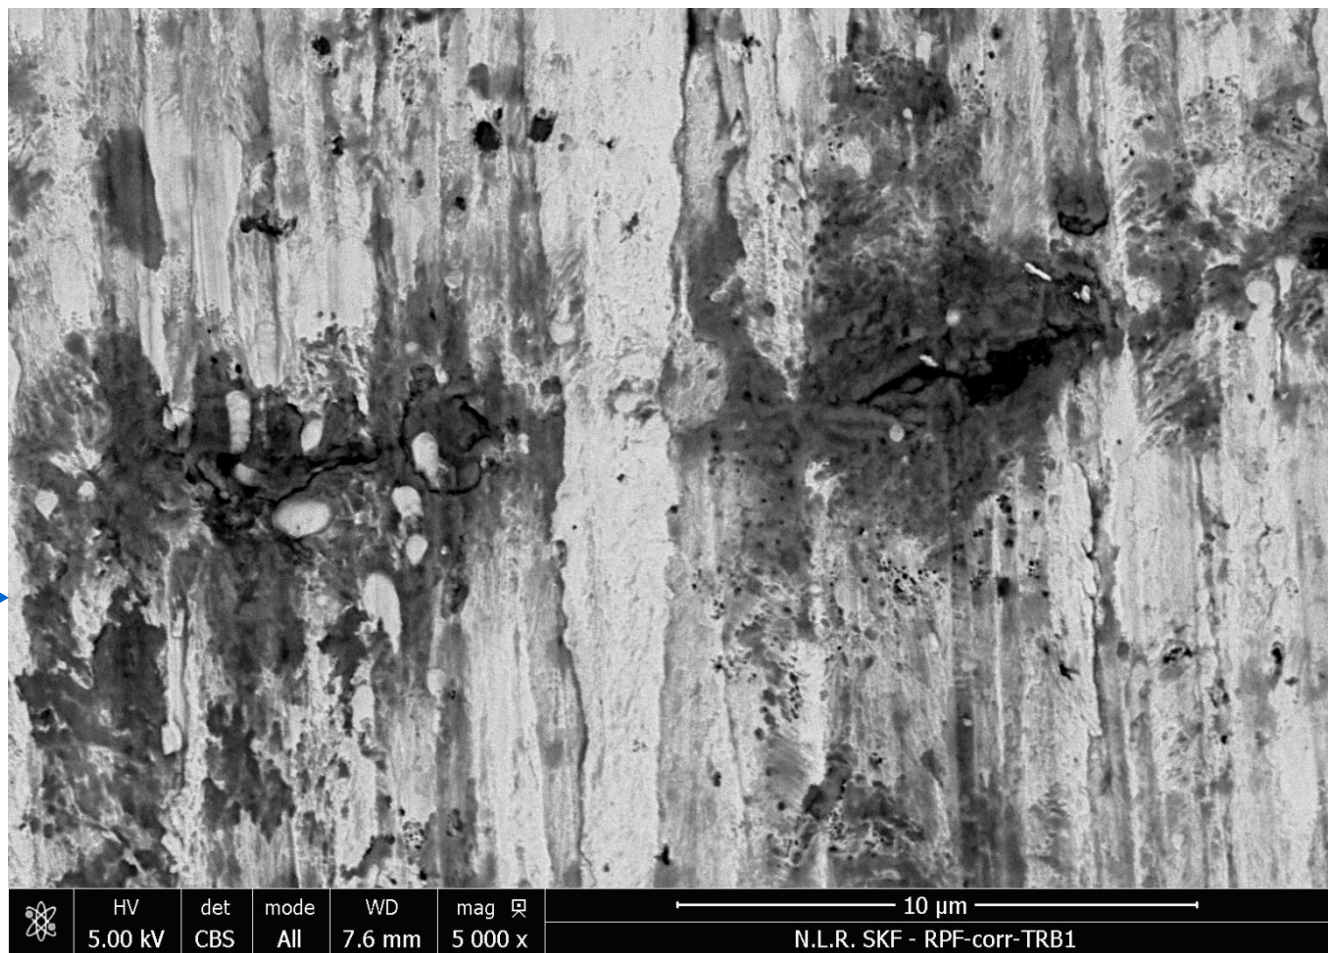
Standstill corrosion marks after testing

Cracks become visible, axial direction

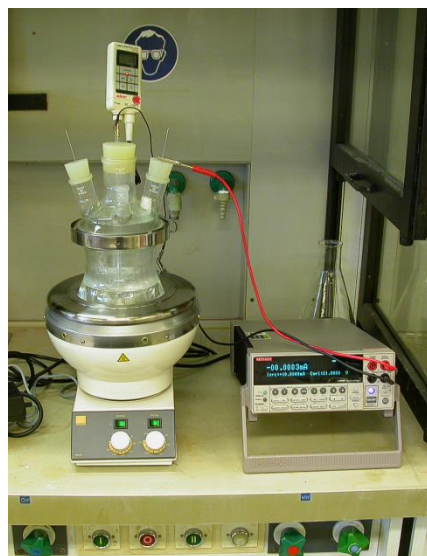
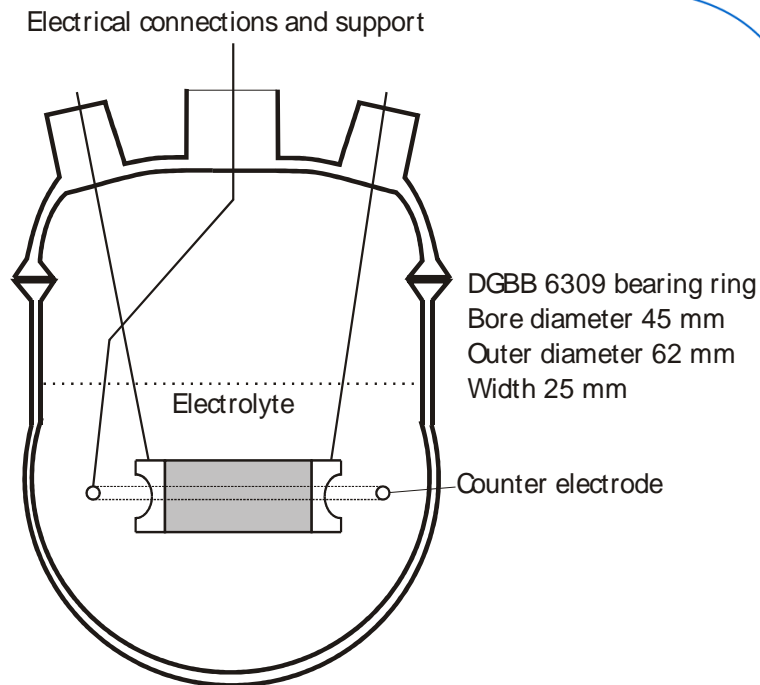
Design of the hydrogen charging cell

- Glass bulb
- Large anode-cathode distance
- Temperature control
- Internal stirring
- Rings up to 100 mm outer diameter

Parameter	Value
Electrolyte	Alkalyne
Temperature	80 °C
pH	11.5-12 at start
Estimated current density	10 mA/cm ²
Polarity workpiece	negative
Time	24 h

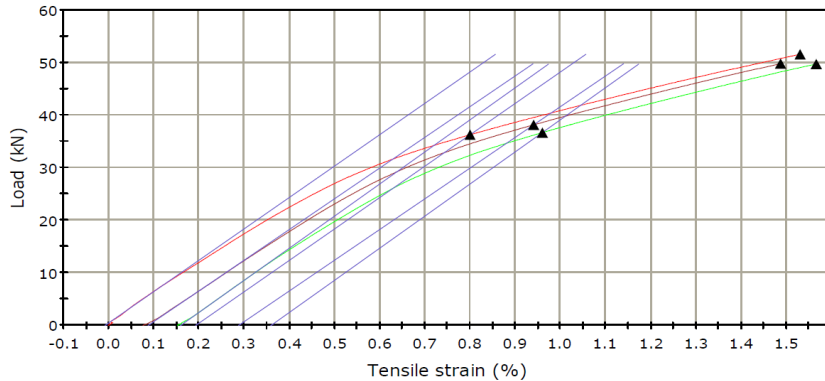
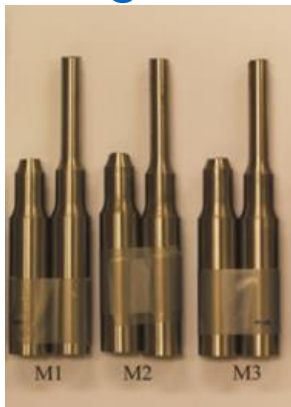
Standard martensite

Specimen 1 to 3

Elongation : 1.4%

Failure at region of change in diameter

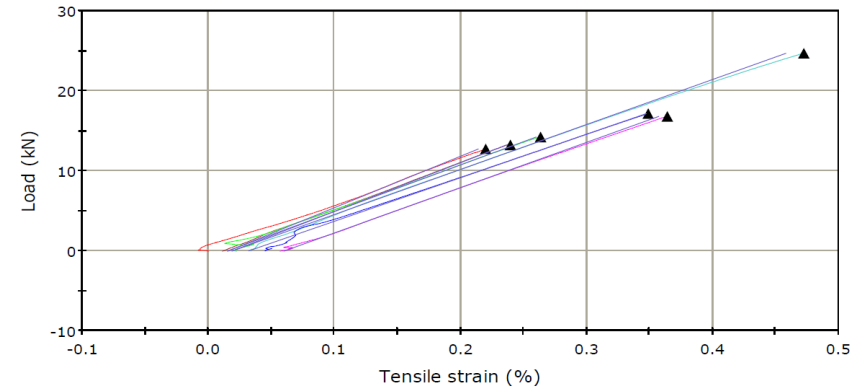
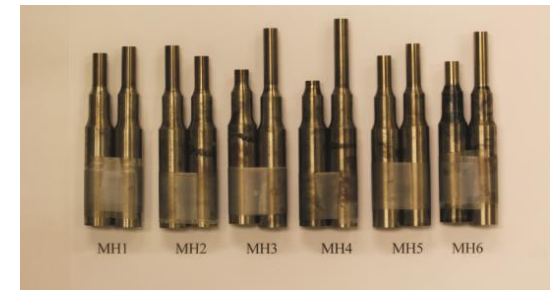
Hydrogen charged

Specimen 1 to 6

Elongation : max. 0.44%

Failure positioned randomly in straight part of test specimen

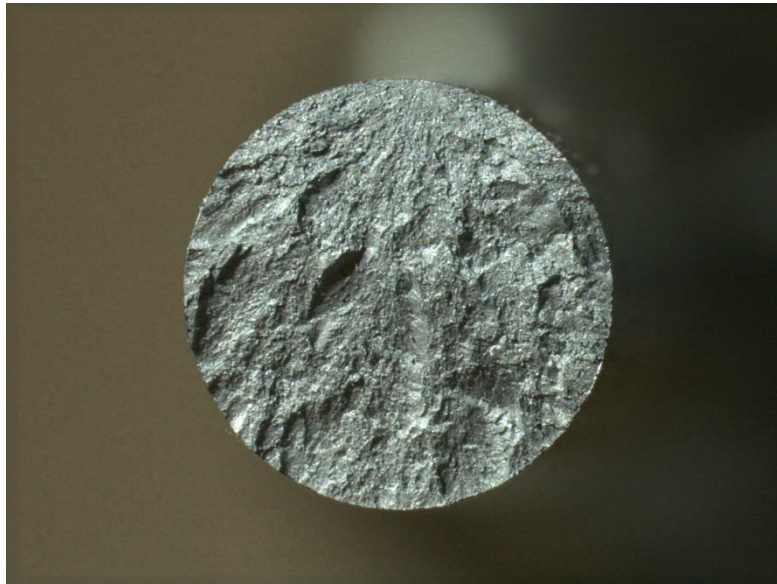
Specimen M2

Standard martensitically hardened steel

Crack initiation at surface

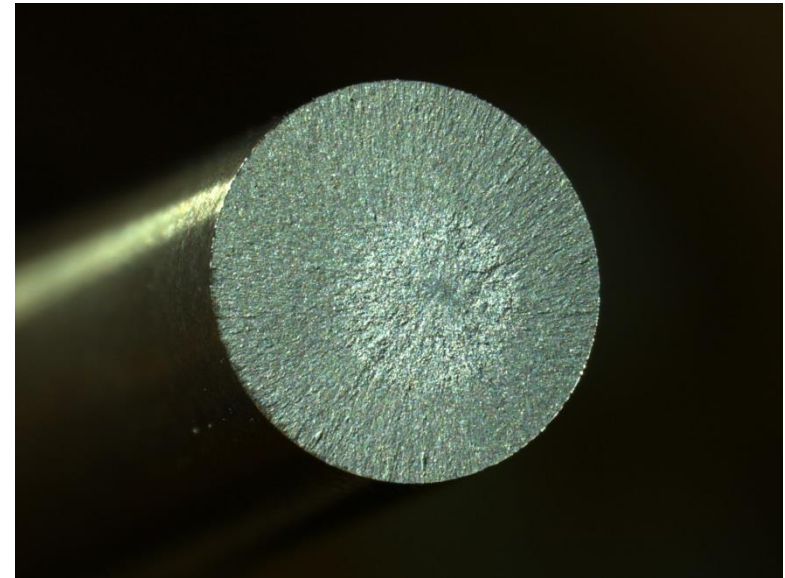
Specimen MH3

Hydrogen charged martensitically hardened steel

Crack initiation in bulk material

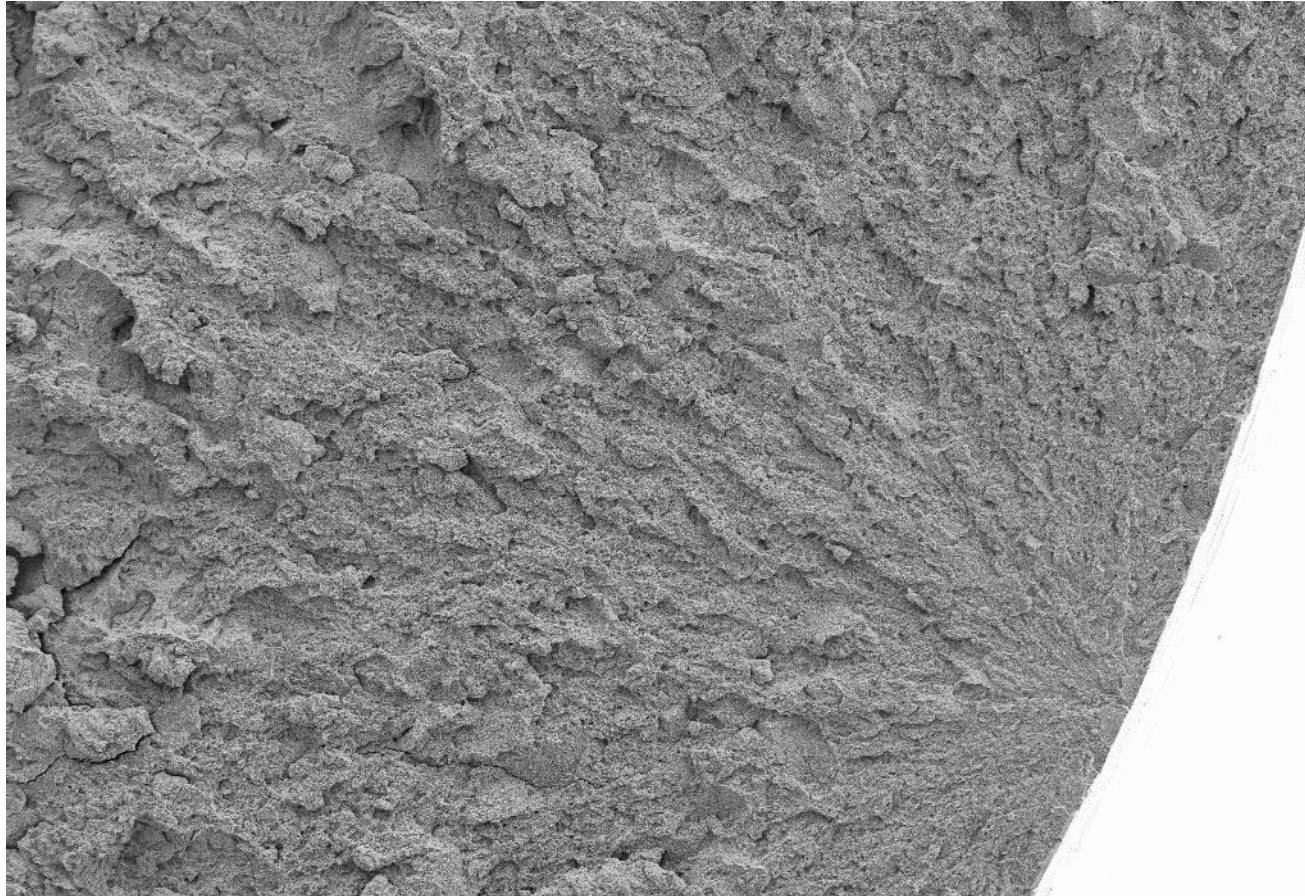
Standard martensitically hardened steel

Crack initiation at surface of the test specimen

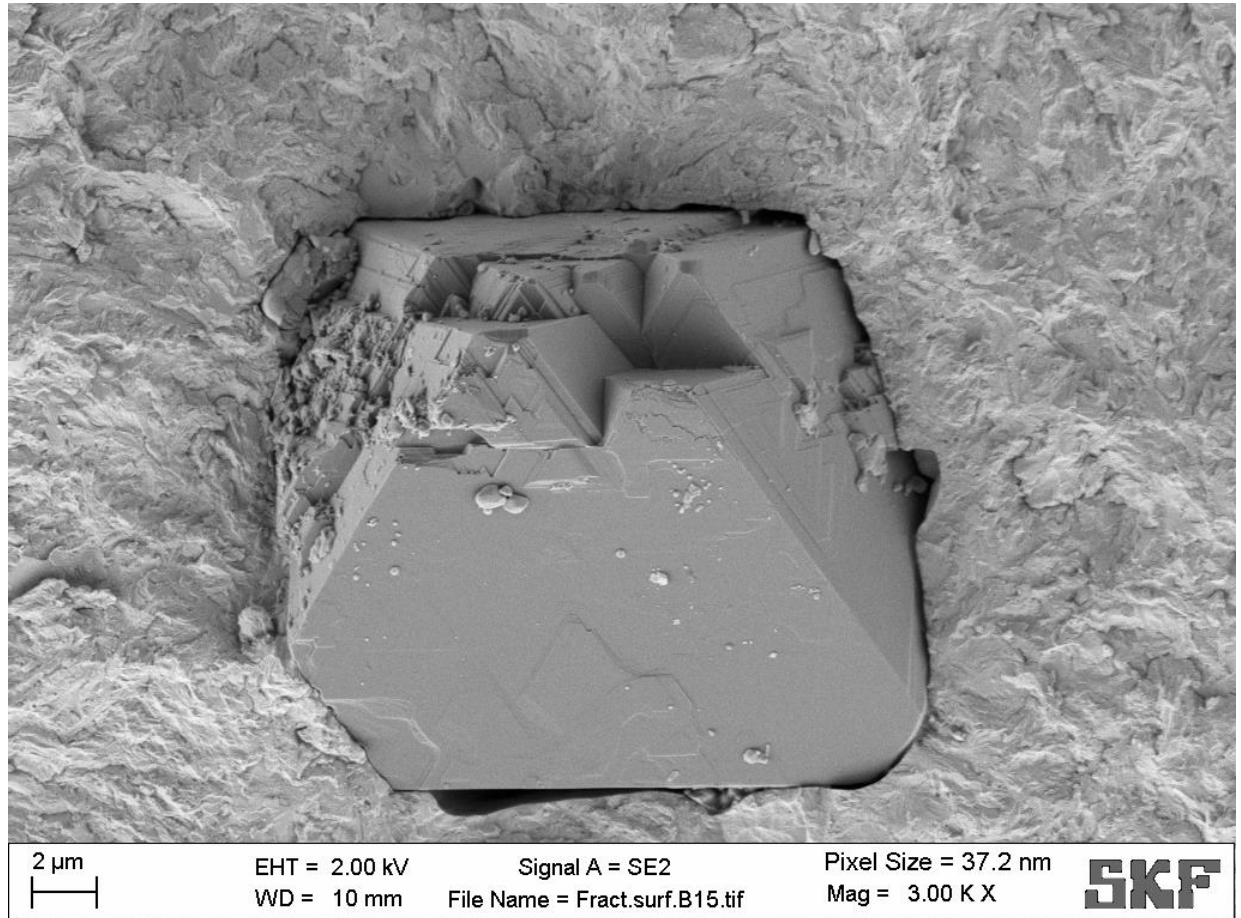
Hydrogen charged martensitically hardened steel

Chemical (EDS) analysis of crack initiating inclusion:

- Al 24 wt%
- Mg 11 wt%
- O 64 wt%

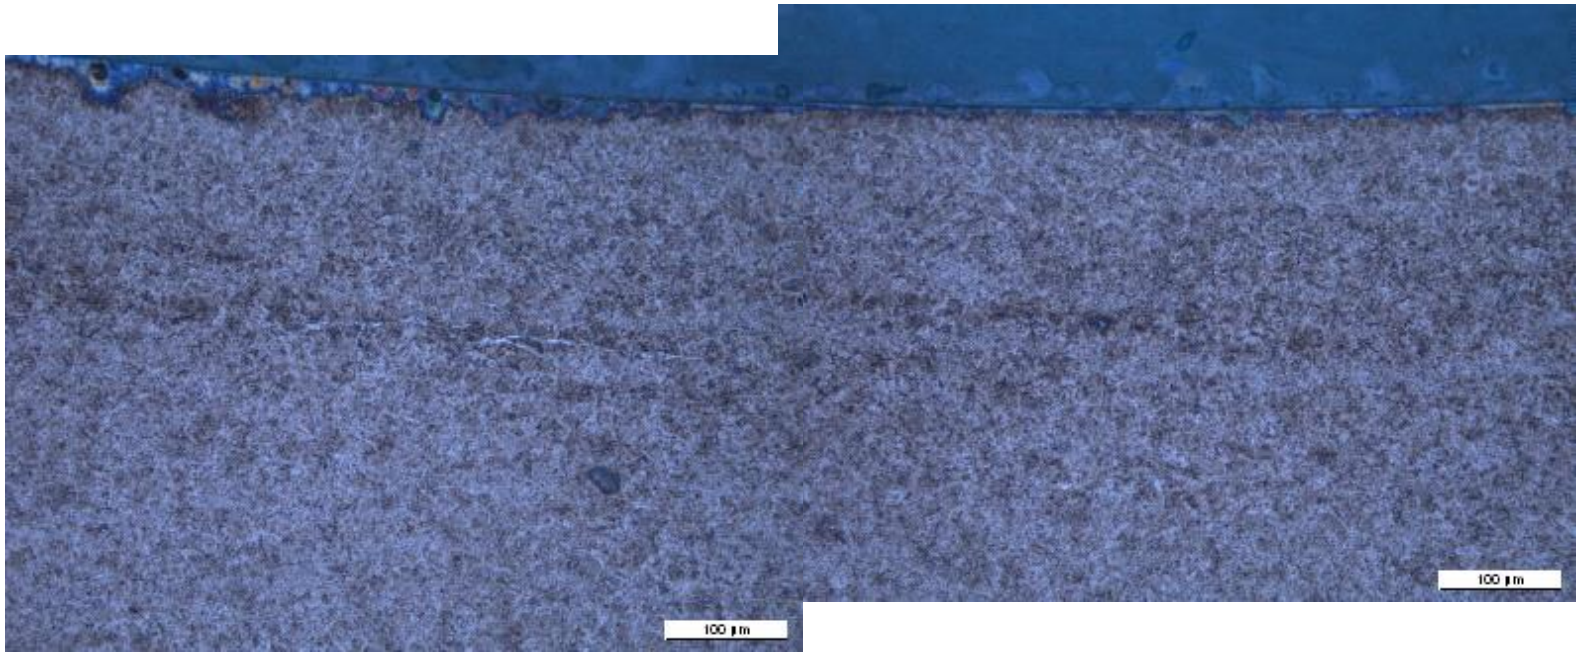
Subsurface microstructure bearing 1

Microstructure of bearing 1, tested for $5.2 \cdot 10^6$ revolutions at 2.8 GPa and 83 °C

Bearing running time in this test is \ll nominal life
