Material weakening due to corrosion in hardened bearing steels

International workshop on the environmental
damage in structural materials under static
load/cyclic loads at ambient temperatures

Cork, Ireland, June 1st, 2016

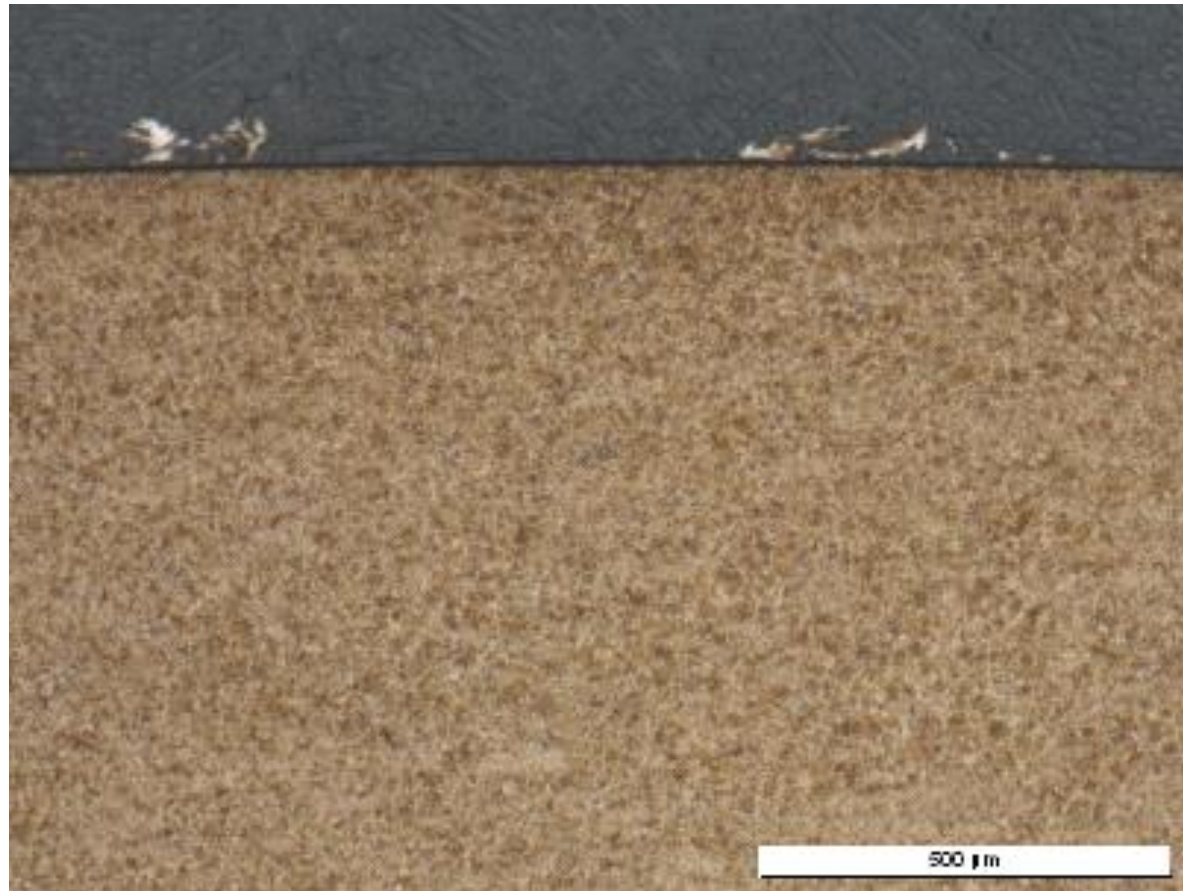
Subsurface microstructure bearing 2

Microstructure of bearing 2, tested for $5.2 \cdot 10^6$ revolutions at 1.6 GPa and 83 °C

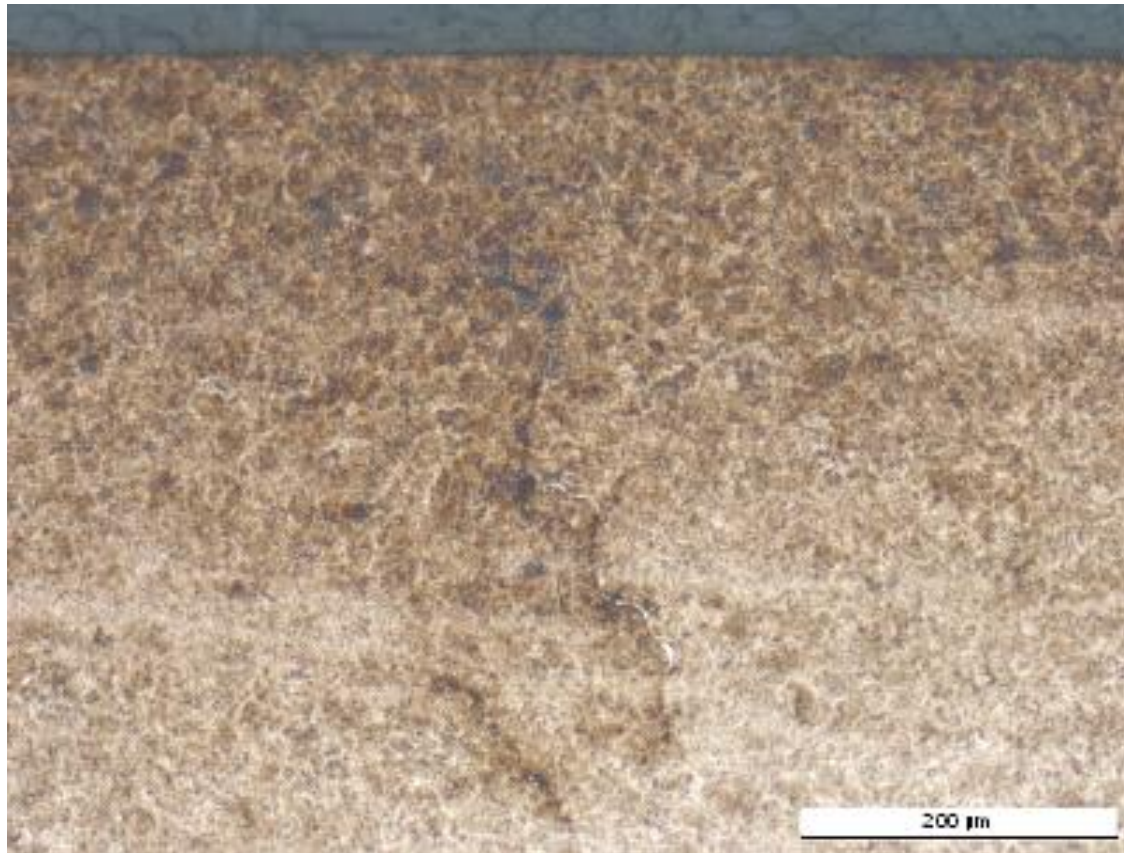
Subsurface microstructure bearing 3

Microstructure of bearing 3, tested for $5.2 \cdot 10^7$ revolutions at 2.0 GPa and 83 °C

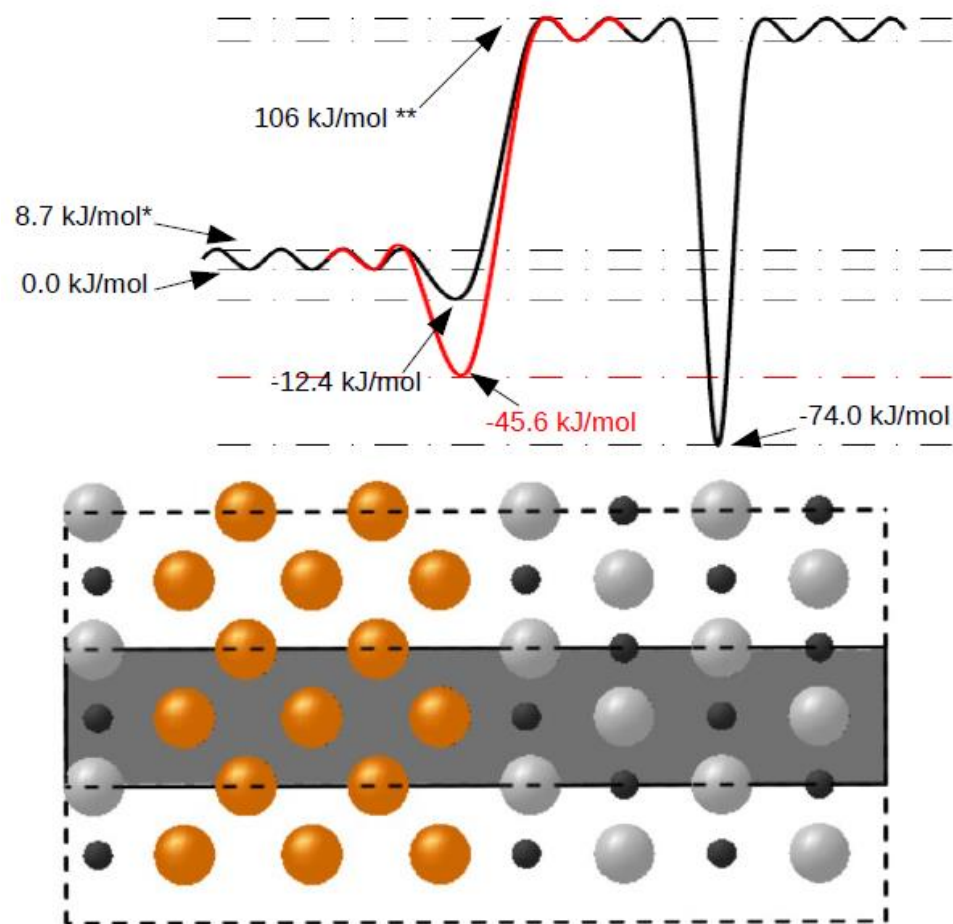
Fe-VC interfaces

Energy landscape of Fe-VC interface shows trapping at interface
